**Flood Control Project Maintenance  
Levee Inspections**

**Fall 2013 Levee Maintenance Deficiency Summary Report**

**San Joaquin River Basin**

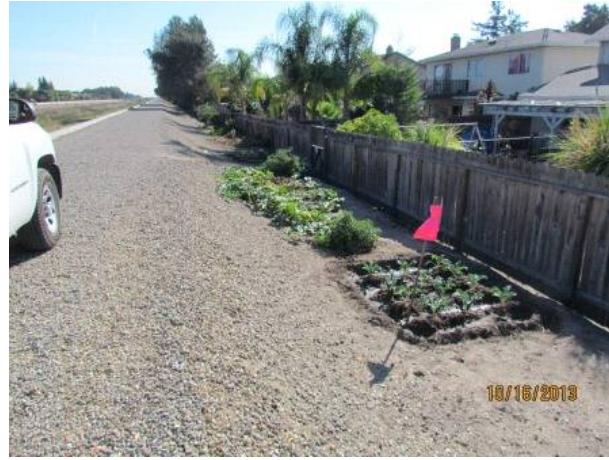
Levee Mile Report Line	72
Start Levee Mile	2.47
End Levee Mile	2.47
Location	Land Side
Category	Earthen Levee
Item	Vegetation
Landscaping was found on the landside toe of the levee looking upstream.	
pkazi_f_20131028_008.JPG

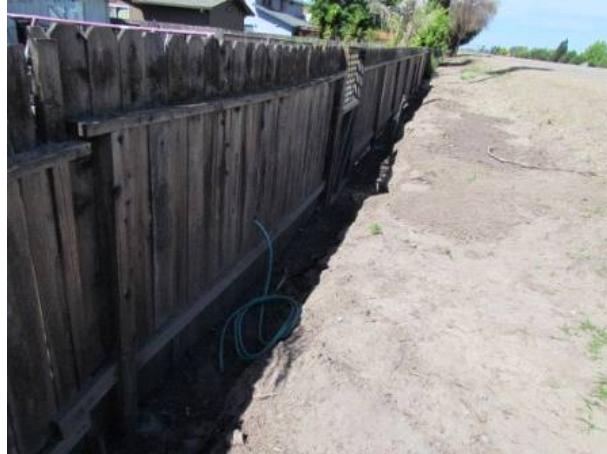
Levee Mile Report Line	73
Start Levee Mile	2.48
End Levee Mile	2.48
Location	Land Side
Category	Earthen Levee
Item	Encroachments
The owner excavated a ditch on the toe at the landside of the levee. The picture was taken from the landside of the levee looking downstream.	
pkazi_f_20131001_109.jpg

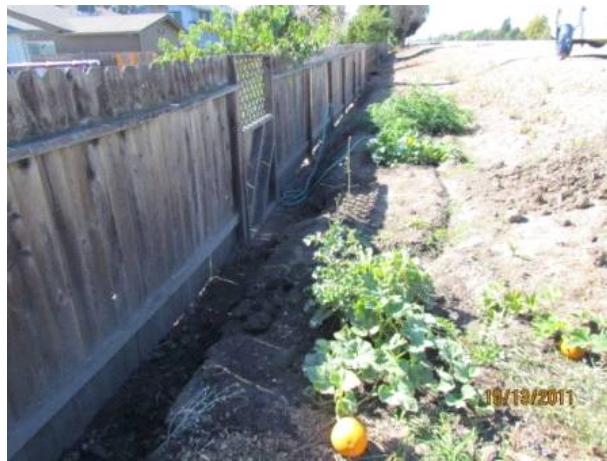
Levee Mile Report Line	73
Start Levee Mile	2.48
End Levee Mile	2.48
Location	Land Side
Category	Earthen Levee
Item	Encroachments
View of a ditch at the landside toe of the levee looking downstream.	
pkazi_f_20131001_110.jpg

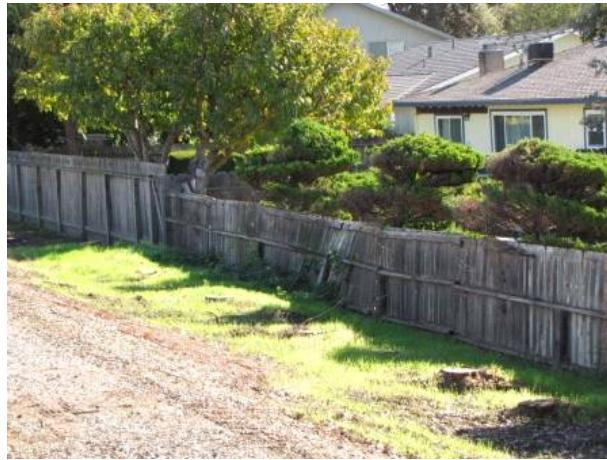
Levee Mile Report Line	74
Start Levee Mile	2.55
End Levee Mile	2.55
Location	Land Side
Category	Earthen Levee
Item	Trim / Thin Trees
View of stumps along the landward toe looking upstream.	
pkazi_f_20131001_090.jpg

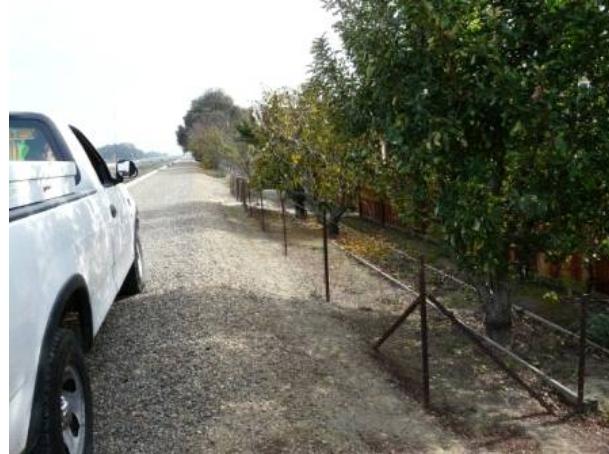
Levee Mile Report Line	76
Start Levee Mile	2.58
End Levee Mile	2.61
Location	Land Side
Category	Earthen Levee
Item	Encroachments
Fence located on shoulder of landside of levee from LM 2.58 to LM 2.61	pkazi_f_20131001_108.JPG

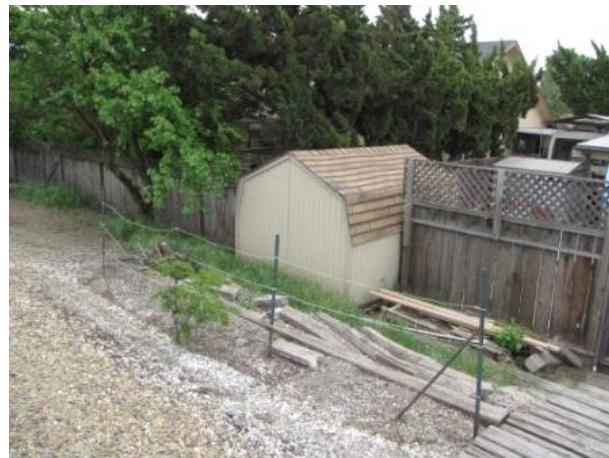
Levee Mile Report Line	77
Start Levee Mile	2.61
End Levee Mile	2.61
Location	Land Side
Category	Earthen Levee
Item	Encroachments
Landscaping and shed placed on landward levee slope and within 10' of the toe.	pkazi_f_20131001_148.jpg

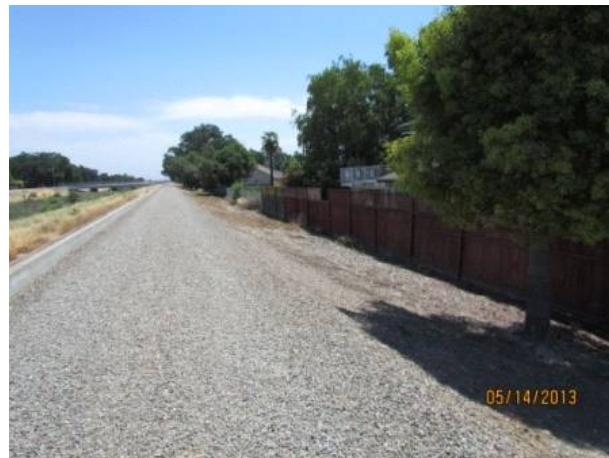
Levee Mile Report Line	81
Start Levee Mile	2.77
End Levee Mile	2.82
Location	Land Side
Category	Earthen Levee
Item	Encroachments
Fence was found on the landside toe of the levee looking upstream.	pkazi_f_20131001_162.JPG

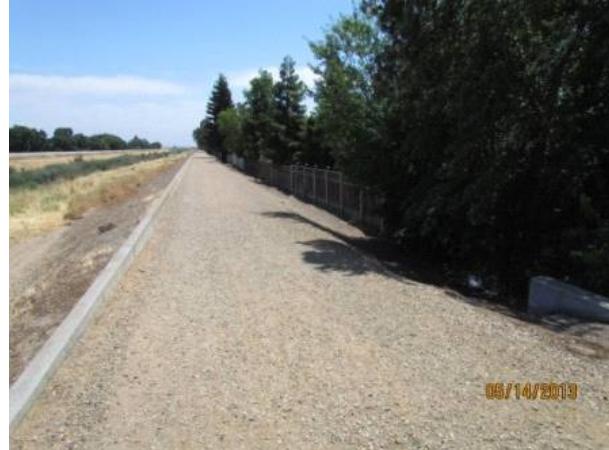
Levee Mile Report Line	84
Start Levee Mile	2.93
End Levee Mile	3.41
Location	Land Side
Category	Earthen Levee
Item	Encroachments
Fence was found on the landside toe of the levee looking upstream.	pkazi_f_20131001_144.JPG

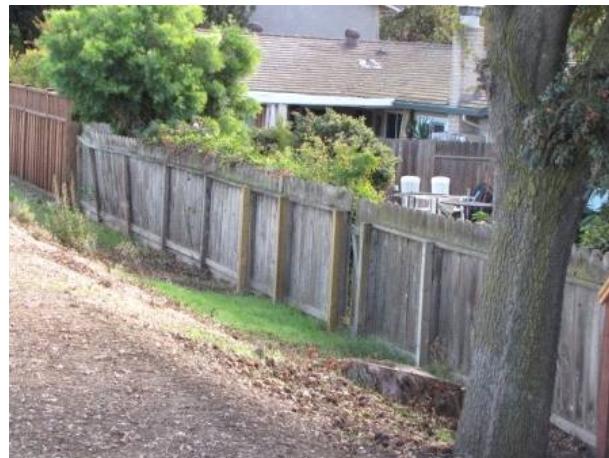
Levee Mile Report Line	85
Start Levee Mile	3.08
End Levee Mile	3.08
Location	Land Side
Category	Earthen Levee
Item	Trim / Thin Trees
View of a stump on the landward slope looking upstream.	pkazi_f_20131001_091.jpg

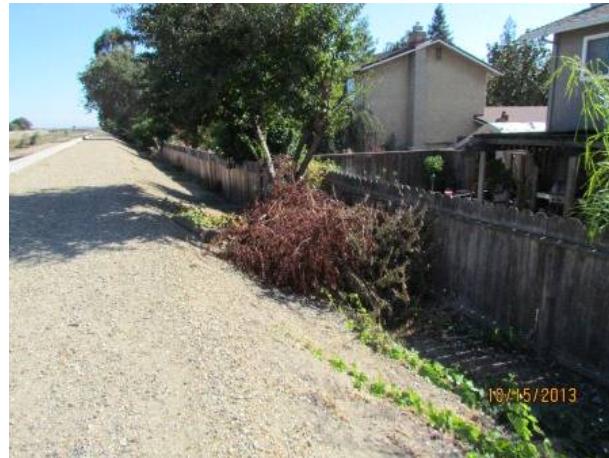
Levee Mile Report Line	86
Start Levee Mile	3.11
End Levee Mile	3.11
Location	Land Side
Category	Earthen Levee
Item	Encroachments
Prunings were found on the landside toe of the levee looking upstream.	pkazi_f_20131026_002.JPG

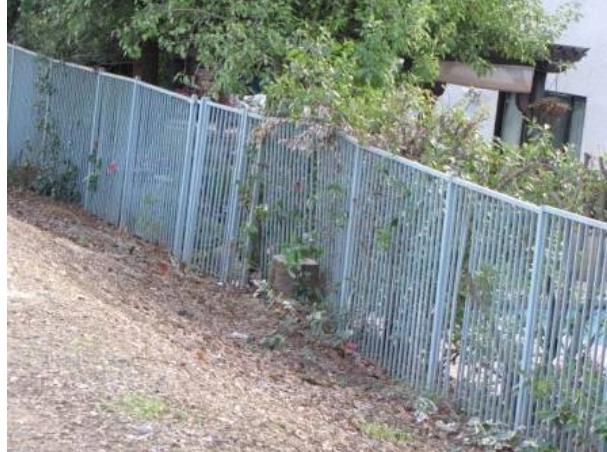
Levee Mile Report Line	87
Start Levee Mile	3.15
End Levee Mile	3.15
Location	Land Side
Category	Earthen Levee
Item	Trim / Thin Trees
View of a stump on the landward slope looking upstream.	
<a href="#">pkazi_f_20131001_092.jpg</a>

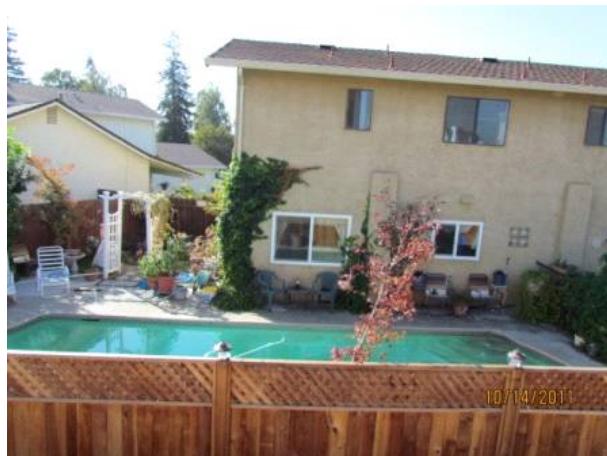
Levee Mile Report Line	88
Start Levee Mile	3.15
End Levee Mile	3.15
Location	Land Side
Category	Earthen Levee
Item	Encroachments
View of the pool located within 10 feet from the toe of the landside of the levee. The picture was taken from the crown looking towards the toe.	
<a href="#">pkazi_f_20131001_145.jpg</a>

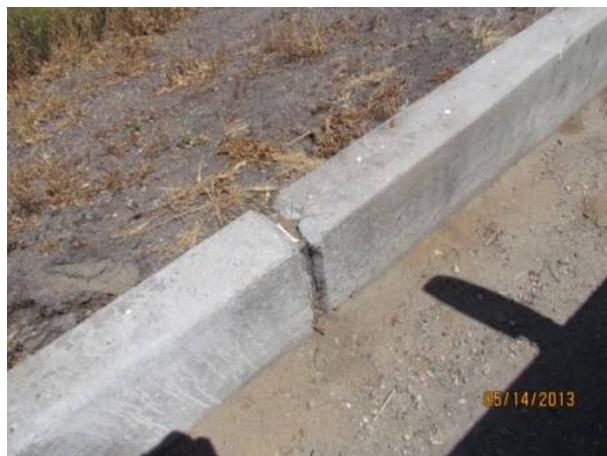
Levee Mile Report Line	89
Start Levee Mile	3.19
End Levee Mile	3.19
Location	Water Side
Category	Concrete Floodwalls
Item	Monolith Joints
The monolith joint material is deteriorating at this location of the flood wall. The picture was taken from the crown looking upstream.	
<a href="#">pkazi_f_20131001_107.JPG</a>

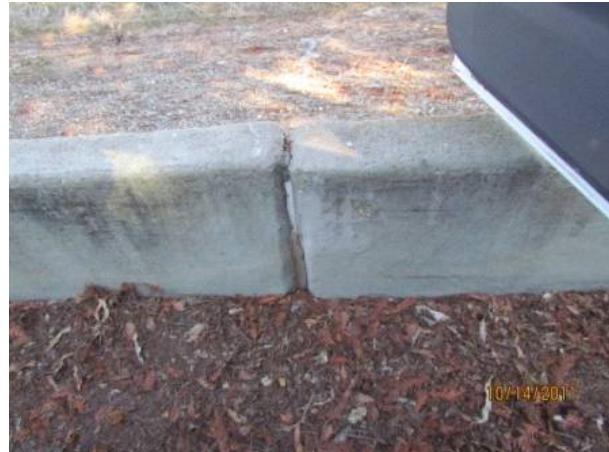
Levee Mile Report Line	90
Start Levee Mile	3.22
End Levee Mile	3.22
Location	Land Side
Category	Concrete Floodwalls
Item	Monolith Joints
Monolith joint material is deteriorating at the joint of the flood wall. The picture was taken from the crown looking upstream.	
pkazi_f_20131001_146.jpg

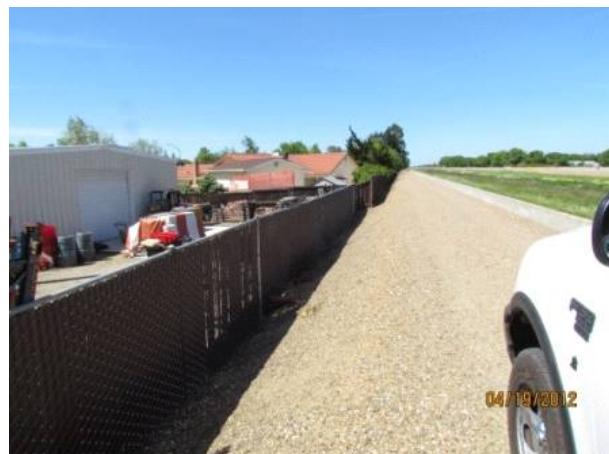
Levee Mile Report Line	92
Start Levee Mile	3.34
End Levee Mile	3.41
Location	Land Side
Category	Earthen Levee
Item	Encroachments
Fences were found on the landside of the levee looking downstream.	
pkazi_f_20131001_138.jpg

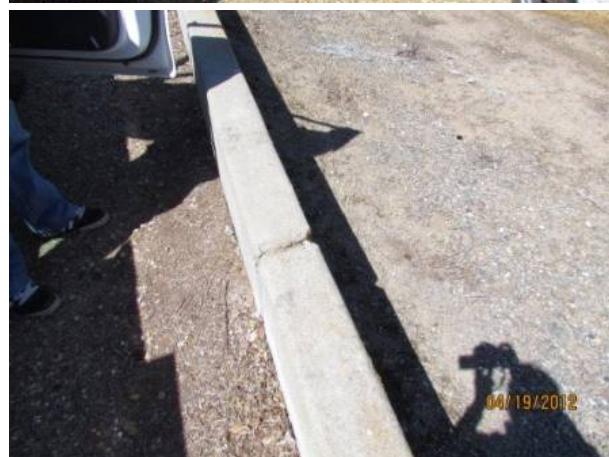
Levee Mile Report Line	93
Start Levee Mile	3.40
End Levee Mile	3.40
Location	Water Side
Category	Concrete Floodwalls
Item	Monolith Joints
The monolith joint material is deteriorating on the waterside of the levee looking downstream.	
pkazi_f_20131001_104.jpg

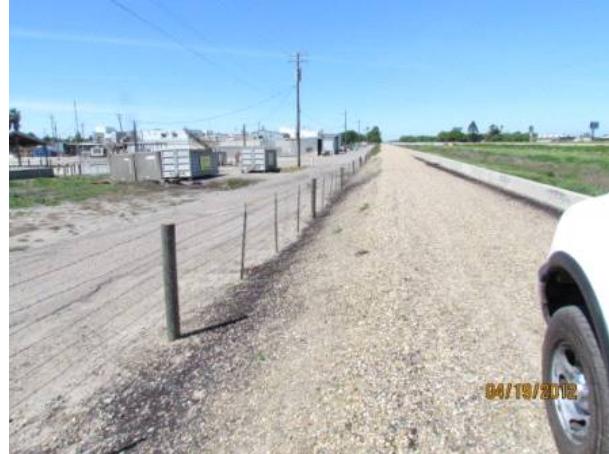
Levee Mile Report Line	94
Start Levee Mile	3.56
End Levee Mile	3.72
Location	Land Side
Category	Earthen Levee
Item	Encroachments
A fence was found on the landside toe of the levee looking downstream.	
pkazi_f_20131001_094.jpg

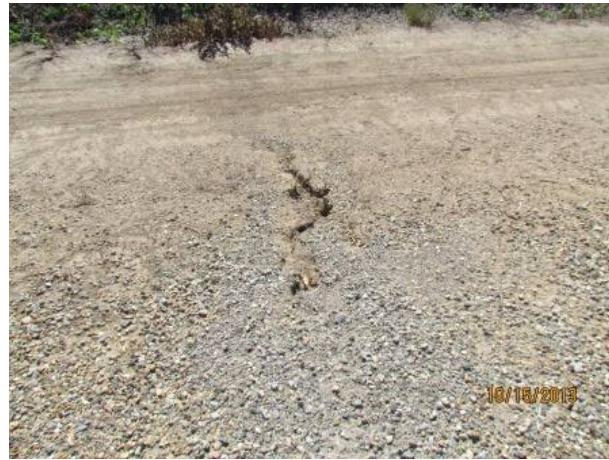
Levee Mile Report Line	96
Start Levee Mile	4.34
End Levee Mile	4.34
Location	Land Side
Category	Earthen Levee
Item	Erosion / Bank Caving
Runoff damage was found on the landside of the levee looking upstream.	
pkazi_f_20131026_003.JPG

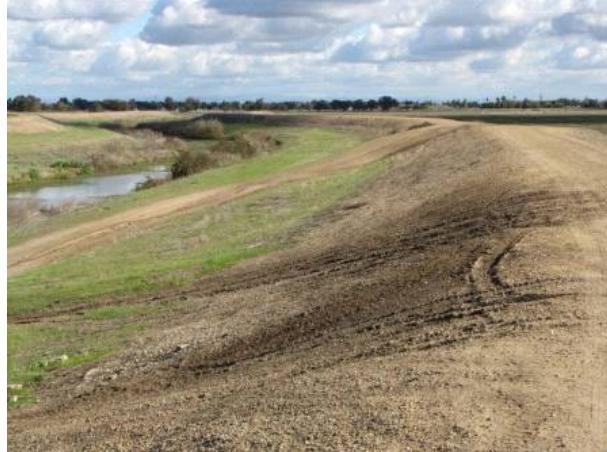
Levee Mile Report Line	98
Start Levee Mile	6.24
End Levee Mile	6.24
Location	Water Side
Category	Earthen Levee
Item	Slope Stability
View of damage to the waterward slope of the levee due to vehicle traffic looking upstream.	
<a href="#">pkazi_f_20131001_100.jpg</a>

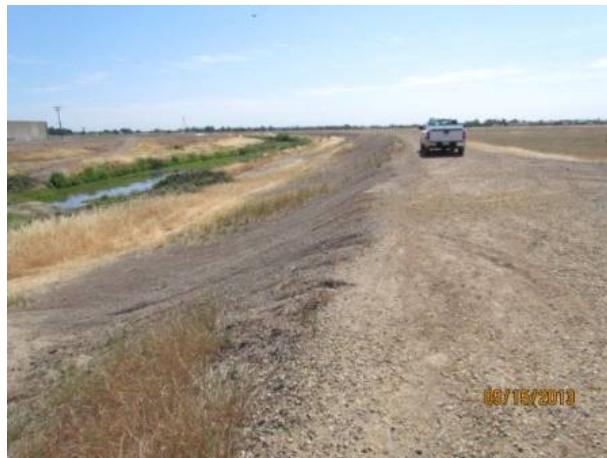
Levee Mile Report Line	98
Start Levee Mile	6.24
End Levee Mile	6.24
Location	Water Side
Category	Earthen Levee
Item	Slope Stability
Updated picture of the slope instability on the landside slope of the levee looking upstream.	
<a href="#">pkazi_f_20131001_101.JPG</a>

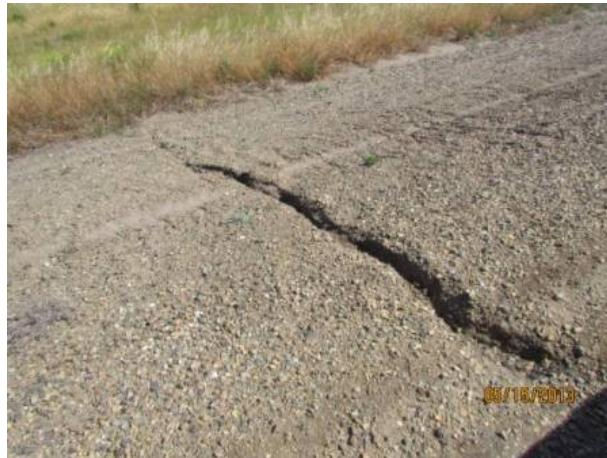
Levee Mile Report Line	101
Start Levee Mile	6.68
End Levee Mile	6.68
Location	Water Side
Category	Earthen Levee
Item	Erosion / Bank Caving
Erosion caused by runoff was found on the waterside slope of the levee looking upstream.	
<a href="#">pkazi_f_20131001_121.JPG</a>

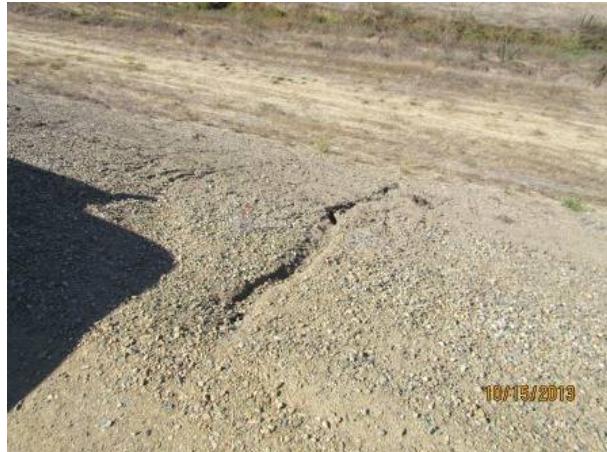
Levee Mile Report Line	101
Start Levee Mile	6.68
End Levee Mile	6.68
Location	Water Side
Category	Earthen Levee
Item	Erosion / Bank Caving
Updated picture of the erosion caused by runoff on the landside slope of the levee.	
pkazi_f_20131026_004.JPG

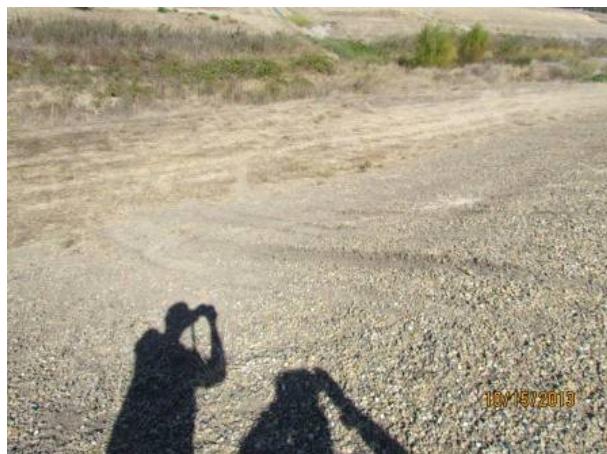
Levee Mile Report Line	102
Start Levee Mile	6.82
End Levee Mile	6.82
Location	Water Side
Category	Earthen Levee
Item	Slope Stability
Slope instability caused by vehicle on the landside of the levee looking upstream.	
pkazi_f_20131026_005.JPG

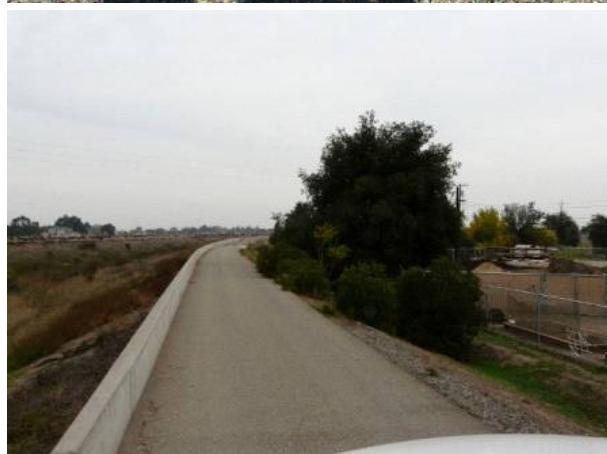
Levee Mile Report Line	103
Start Levee Mile	7.57
End Levee Mile	7.62
Location	Land Side
Category	Earthen Levee
Item	Vegetation
Landscaping along landside slope of levee from LM 7.57 to 7.62	
pkazi_f_20131001_117.JPG

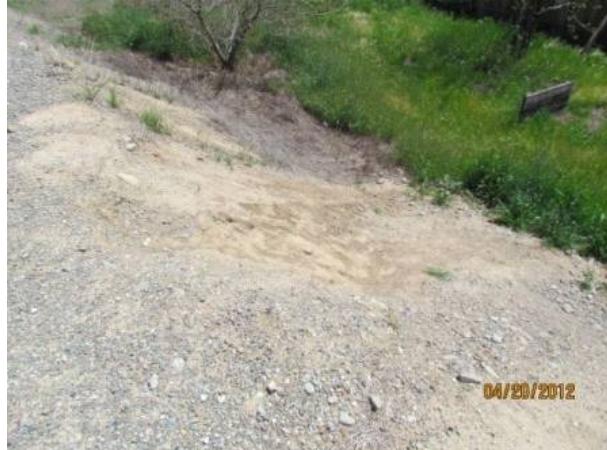
Levee Mile Report Line	104
Start Levee Mile	7.65
End Levee Mile	7.65
Location	Land Side
Category	Earthen Levee
Item	Slope Stability
Erosion was found on the landside of the levee looking upstream.	
pkazi_f_20131001_114.jpg

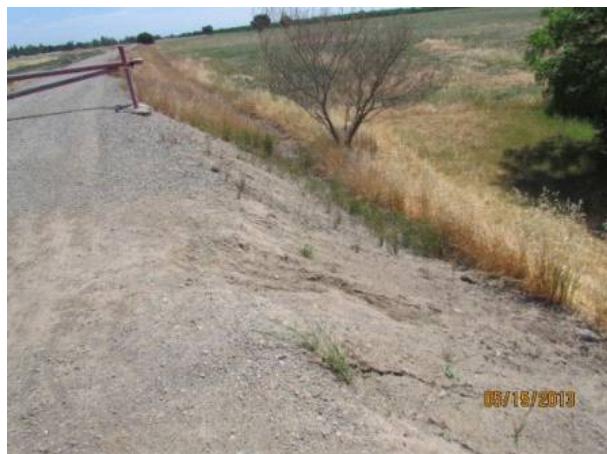
Levee Mile Report Line	104
Start Levee Mile	7.65
End Levee Mile	7.65
Location	Land Side
Category	Earthen Levee
Item	Slope Stability
Slope instability was found due to foot traffic on the landside of the levee looking upstream.	
pkazi_f_20131001_115.JPG

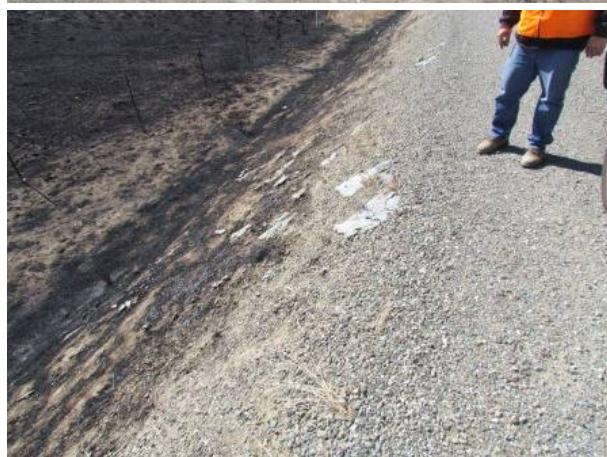
Levee Mile Report Line	107
Start Levee Mile	8.23
End Levee Mile	8.23
Location	Land Side
Category	Earthen Levee
Item	Animal Control
An animal hole was repaired by the LMA on the landside slope of the levee looking downstream.	
pkazi_f_20131028_009.JPG

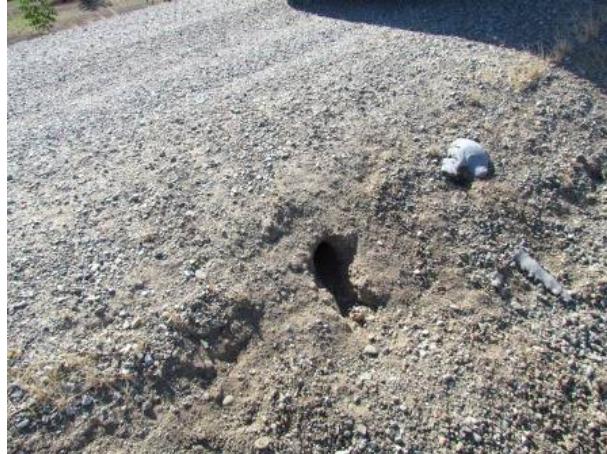
Levee Mile Report Line	108
Start Levee Mile	8.37
End Levee Mile	8.37
Location	Water Side
Category	Earthen Levee
Item	Animal Control
A rodent hole was found on the waterside shoulder of the levee looking downstream.	
pkazi_f_20131028_010.JPG

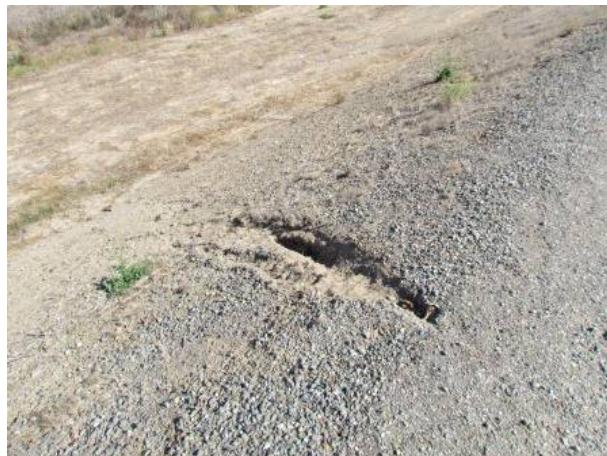
Levee Mile Report Line	109
Start Levee Mile	8.56
End Levee Mile	8.56
Location	Water Side
Category	Earthen Levee
Item	Erosion / Bank Caving
A runoff was found on the waterside slope of the levee looking upstream.	
pkazi_f_20131028_011.JPG

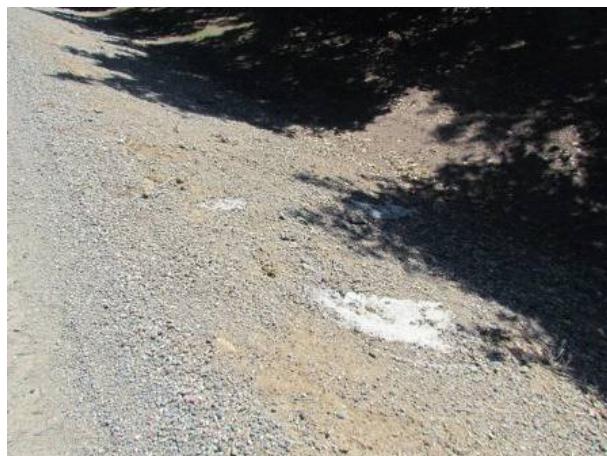
Levee Mile Report Line	111
Start Levee Mile	8.90
End Levee Mile	8.90
Location	Land Side
Category	Earthen Levee
Item	Animal Control
Rodent holes were fixed by the LMA on the landside of the levee looking upstream.	
pkazi_f_20131028_012.JPG

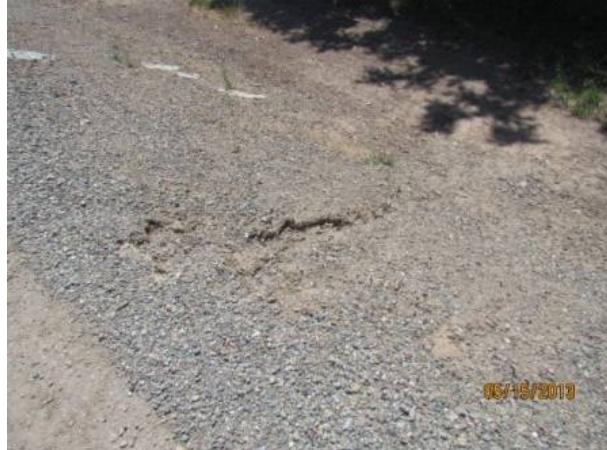
Levee Mile Report Line	113
Start Levee Mile	9.04
End Levee Mile	9.04
Location	Land Side
Category	Earthen Levee
Item	Erosion / Bank Caving
Erosion caused by runoff was found on the landside slope of the levee looking upstream.	
pkazi_f_20131001_132.JPG

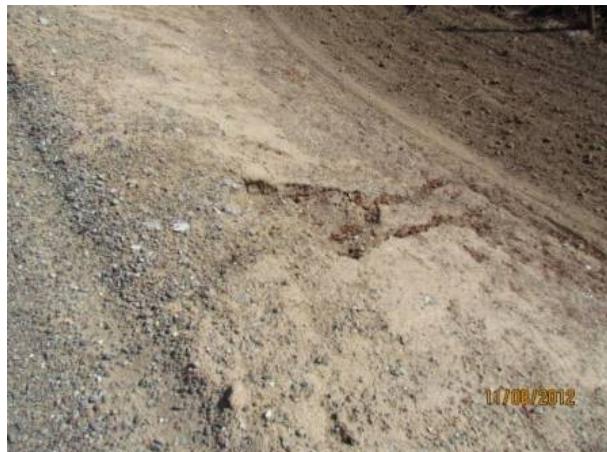
Levee Mile Report Line	115
Start Levee Mile	9.48
End Levee Mile	9.48
Location	Land Side
Category	Earthen Levee
Item	Erosion / Bank Caving
Slope instability was found on the landside slope of the levee looking upstream.	
pkazi_f_20131001_141.jpg

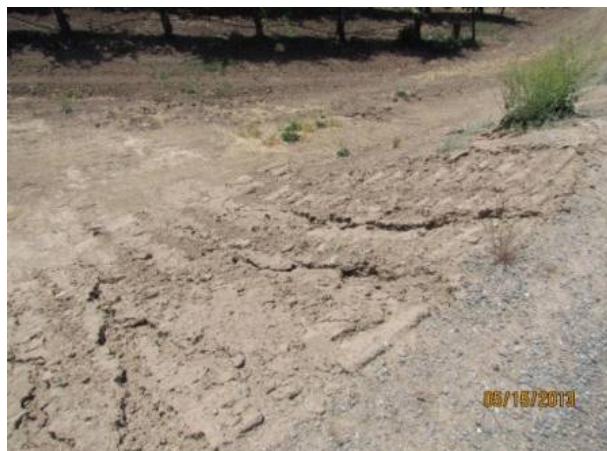
Levee Mile Report Line	115
Start Levee Mile	9.48
End Levee Mile	9.48
Location	Land Side
Category	Earthen Levee
Item	Erosion / Bank Caving
Updated picture of the erosion caused by runoff on the landside of the levee looking downstream.	
pkazi_f_20131001_142.JPG

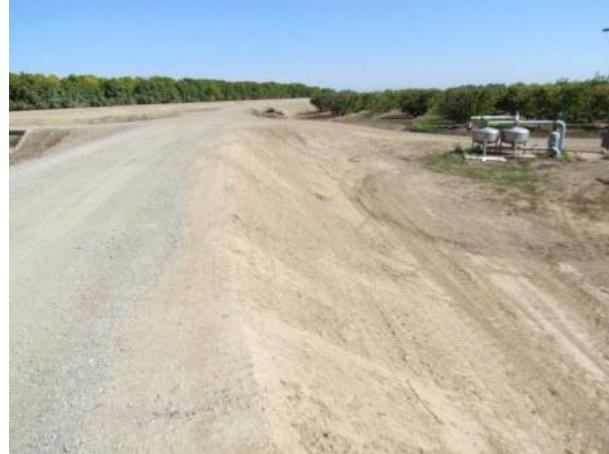
Levee Mile Report Line	116
Start Levee Mile	9.49
End Levee Mile	9.49
Location	Land Side
Category	Earthen Levee
Item	Slope Stability
Slope instability was repaired by the LMA on the landside slope of the levee looking upstream.	
pkazi_f_20131028_013.JPG

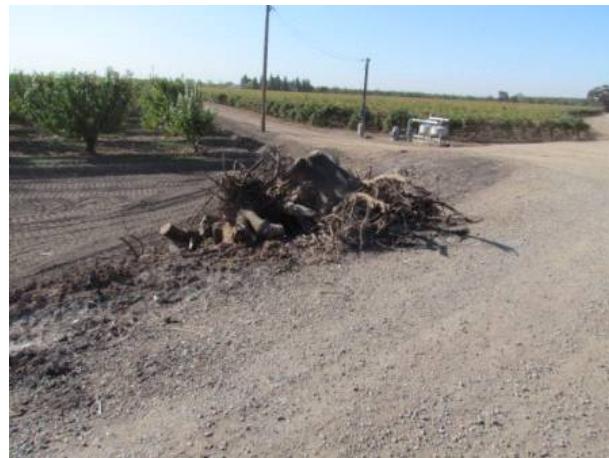
Levee Mile Report Line	117
Start Levee Mile	9.52
End Levee Mile	9.52
Location	Land Side
Category	Earthen Levee
Item	Encroachments
Prunings were found on the landside of the levee looking upstream.	
pkazi_f_20131001_118.jpg

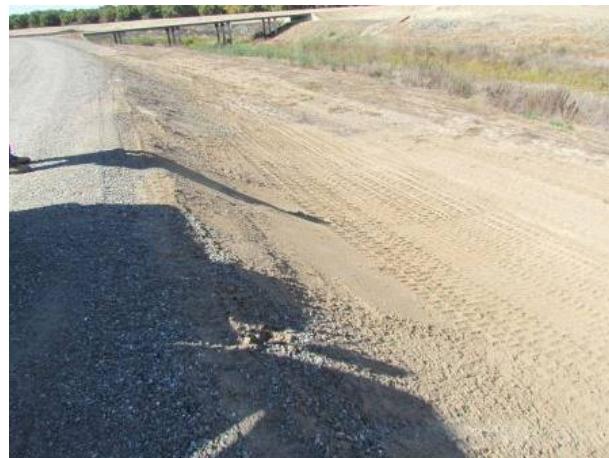
Levee Mile Report Line	119
Start Levee Mile	9.56
End Levee Mile	9.56
Location	Water Side
Category	Earthen Levee
Item	Slope Stability
Slope instability was repaired by the LMA on the waterside slope of the levee looking downstream. The picture was taken during fall 2013 inspection.	
pkazi_f_20131028_014.JPG

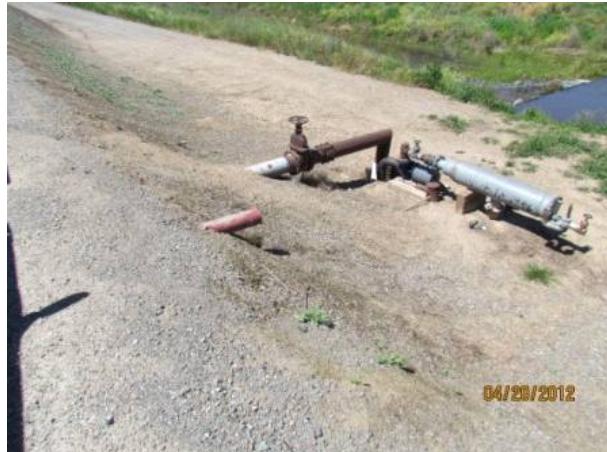
pkazi\_f\_20131001\_119.jpg

An open pipe was found on the waterside of the levee looking downstream.

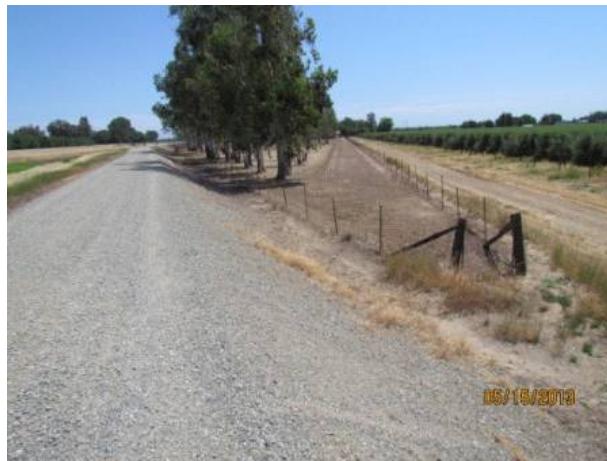
pkazi\_f\_20131001\_147.JPG

Levee Mile Report Line	122
Start Levee Mile	10.23
End Levee Mile	10.45
Location	Land Side
Category	Earthen Levee
Item	Encroachments

Fence was found on the landside toe of the levee looking upstream.

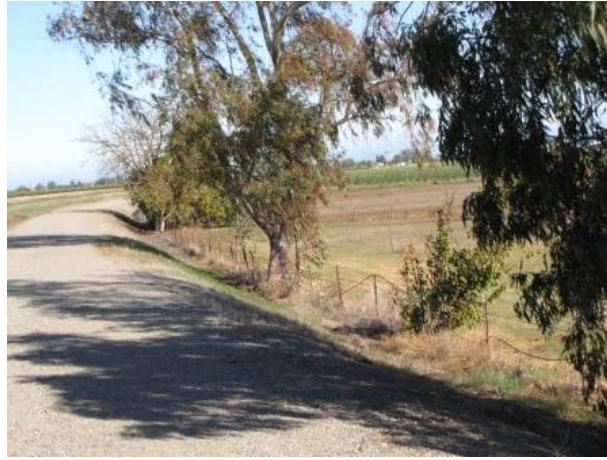
pkazi\_f\_20131001\_202.jpg

Levee Mile Report Line	124
Start Levee Mile	11.47
End Levee Mile	11.64
Location	Land Side
Category	Earthen Levee
Item	Encroachments

View of a fence at the landward toe looking upstream.

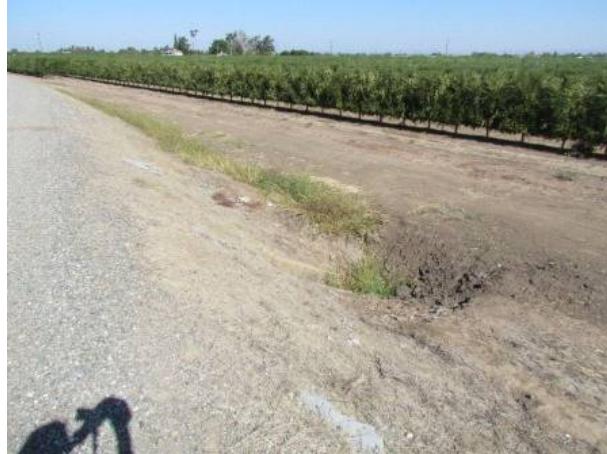
Levee Mile Report Line	126
Start Levee Mile	12.41
End Levee Mile	12.41
Location	Land Side
Category	Earthen Levee
Item	Encroachments
The ditch was repaired by the LMA on the landside toe of the levee looking upstream.	
pkazi_f_20131028_015.JPG

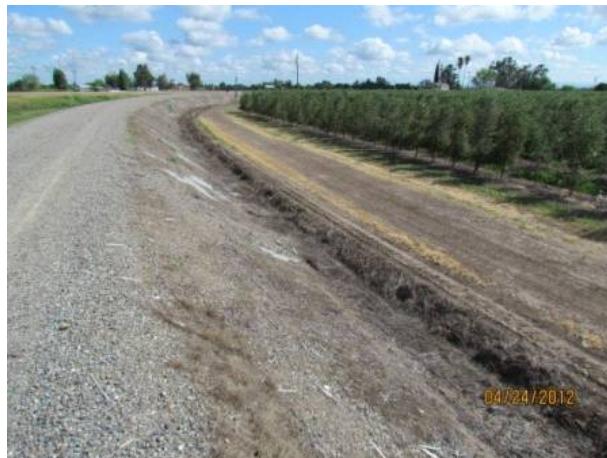
Levee Mile Report Line	128
Start Levee Mile	12.49
End Levee Mile	12.49
Location	Land Side
Category	Earthen Levee
Item	Encroachments
An agricultural ditch was found on the landside toe of the levee looking upstream.	
pkazi_f_20131001_125.jpg

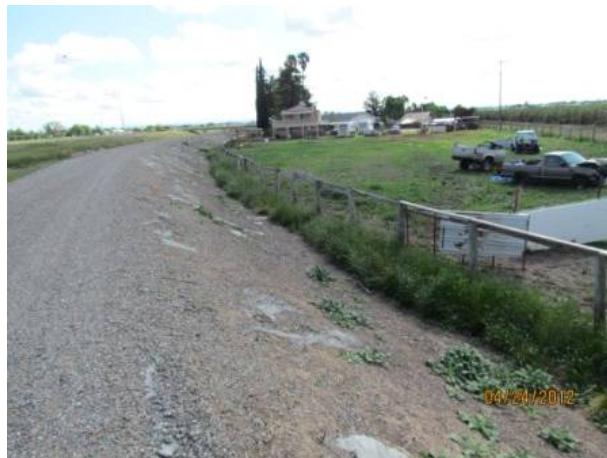
Levee Mile Report Line	129
Start Levee Mile	12.60
End Levee Mile	12.74
Location	Land Side
Category	Earthen Levee
Item	Encroachments
Fence was found on the landside of the levee looking upstream.	
pkazi_f_20131001_122.jpg

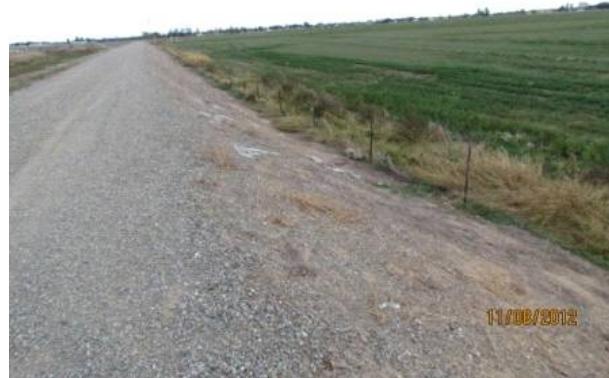
Levee Mile Report Line	130
Start Levee Mile	12.77
End Levee Mile	13.06
Location	Land Side
Category	Earthen Levee
Item	Encroachments
Fence was located on the landside toe of the levee looking upstream.	
pkazi_f_20131001_123.jpg

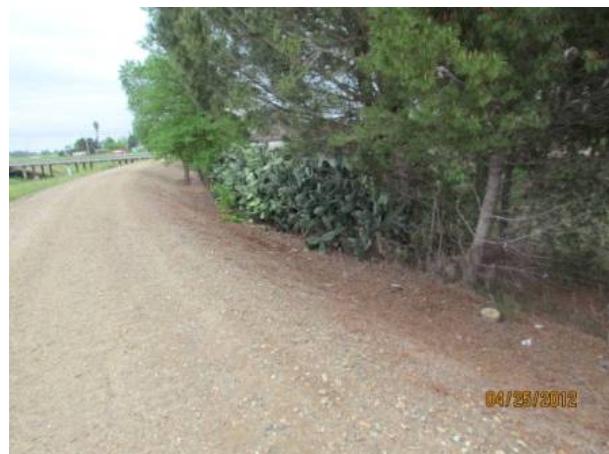
Levee Mile Report Line	133
Start Levee Mile	13.54
End Levee Mile	13.54
Location	Land Side
Category	Earthen Levee
Item	Vegetation
Cacti was found on the landside of the levee looking upstream.	
pkazi_f_20131001_128.jpg

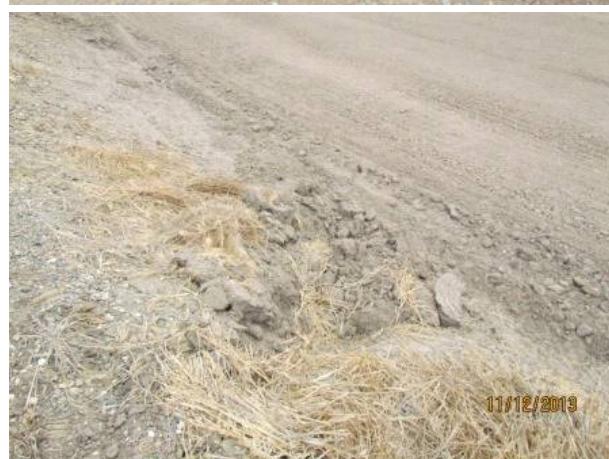
Levee Mile Report Line	134
Start Levee Mile	13.82
End Levee Mile	13.82
Location	Land Side
Category	Earthen Levee
Item	Slope Stability
View of a slope instability on the landside of the levee looking upstream.	
pkazi_f_20131112_044.JPG

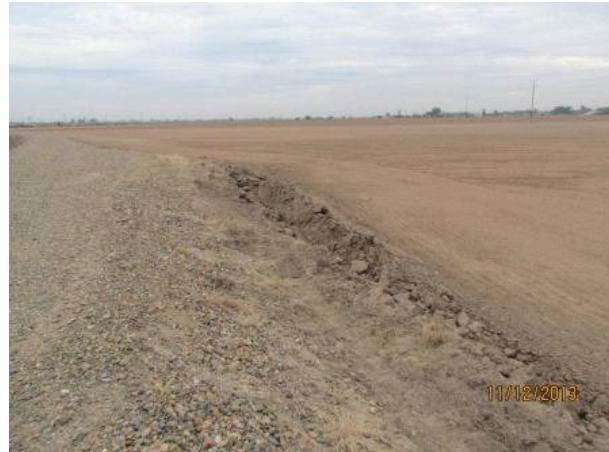
Levee Mile Report Line	136
Start Levee Mile	13.94
End Levee Mile	13.94
Location	Land Side
Category	Earthen Levee
Item	Slope Stability
Slope instability was found on the landside toe of the levee looking upstream.	
pkazi_f_20131112_045.JPG

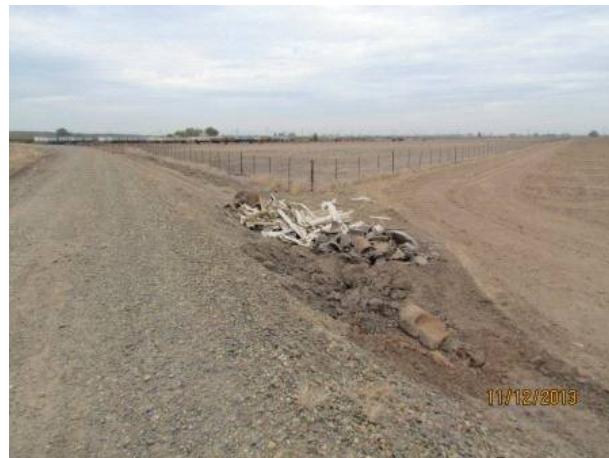
Levee Mile Report Line	137
Start Levee Mile	14.09
End Levee Mile	14.09
Location	Land Side
Category	Earthen Levee
Item	Encroachments
Debris was found on the landside toe of the levee looking upstream.	
pkazi_f_20131112_046.JPG

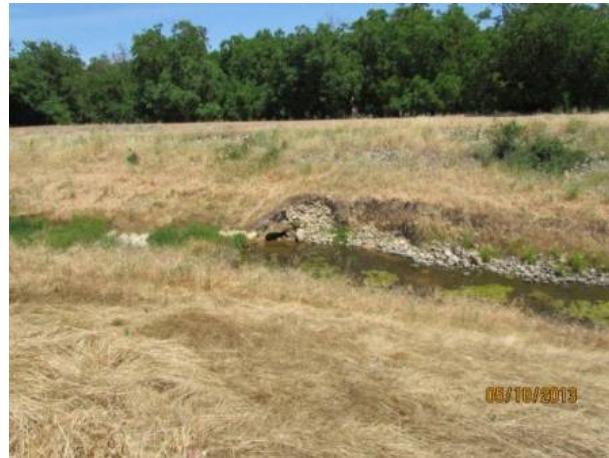
Levee Mile Report Line	141
Start Levee Mile	15.20
End Levee Mile	15.20
Location	Water Side
Category	Earthen Levee
Item	Erosion / Bank Caving
Erosion was found on the waterside toe of the levee. The picture was taken from the opposite side of the levee.	
pkazi_f_20131001_139.JPG

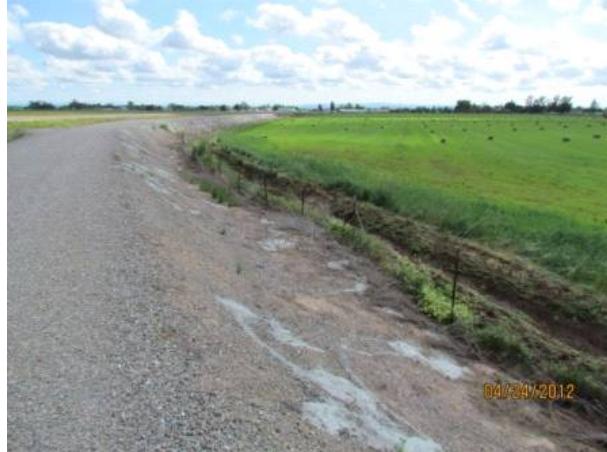
Levee Mile Report Line	1
Start Levee Mile	0.02
End Levee Mile	0.55
Location	Land Side
Category	Earthen Levee
Item	Encroachments
Fences were found on the landside toe of the levee looking upstream.	
pkazi_f_20131001_203.jpg

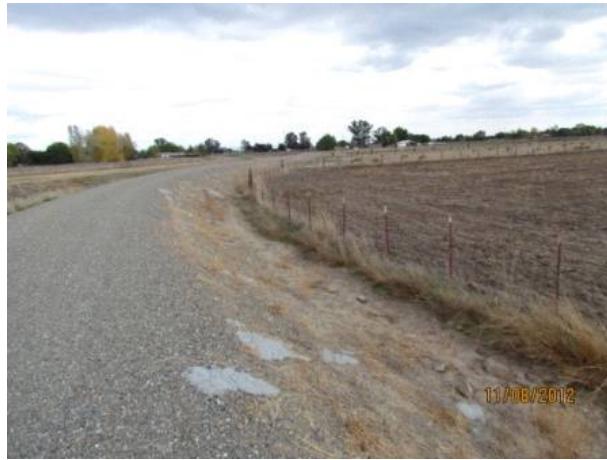
Levee Mile Report Line	4
Start Levee Mile	1.20
End Levee Mile	1.44
Location	Land Side
Category	Earthen Levee
Item	Encroachments
Fence was found on the landside toe of the levee looking upstream.	
pkazi_f_20131001_204.jpg

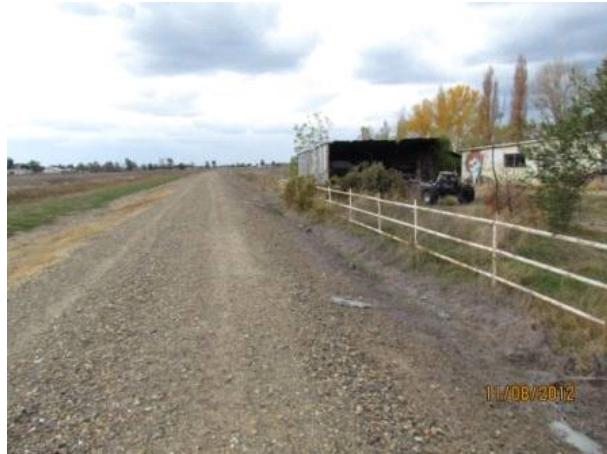
Levee Mile Report Line	1
Start Levee Mile	0.35
End Levee Mile	1.32
Location	Land Side
Category	Earthen Levee
Item	Encroachments
Fence was found on the landside toe of the levee looking downstream.	pkazi_f_20131001_206.jpg

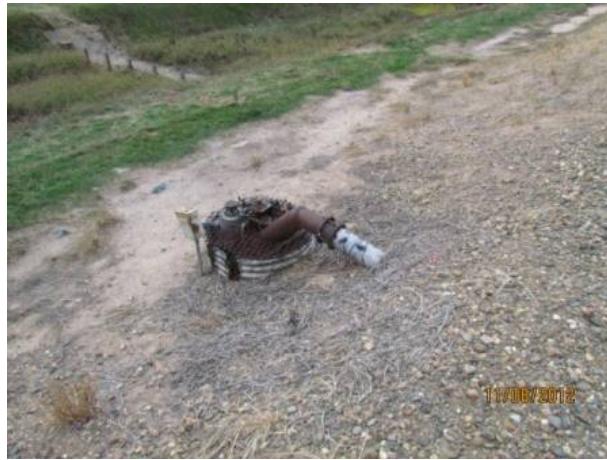
Levee Mile Report Line	3
Start Levee Mile	0.42
End Levee Mile	0.42
Location	Water Side
Category	Earthen Levee
Item	Encroachments
Pipe penetration was found under the crown of the levee looking downstream.	pkazi_f_20131001_211.jpg

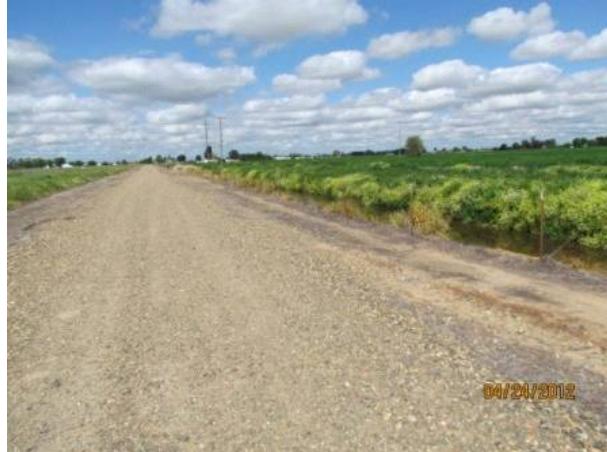
Levee Mile Report Line	4
Start Levee Mile	0.46
End Levee Mile	0.92
Location	Land Side
Category	Earthen Levee
Item	Encroachments
Fences were found on the landside of the levee looking downstream.	pkazi_f_20131001_205.jpg

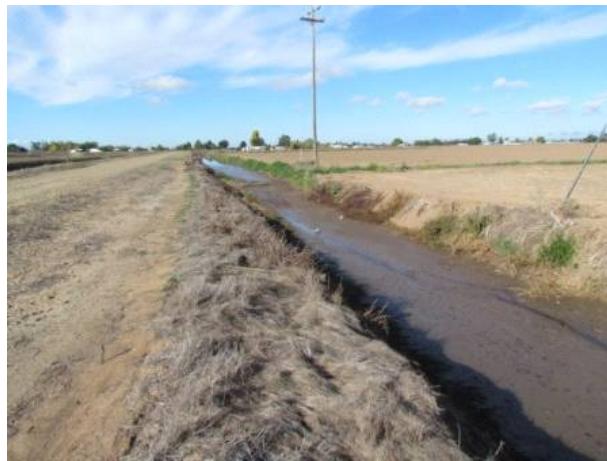
Levee Mile Report Line	5
Start Levee Mile	0.71
End Levee Mile	0.97
Location	Land Side
Category	Earthen Levee
Item	Encroachments
An agricultural ditch was found on the landside of the levee looking downstream.	pkazi_f_20131001_209.jpg

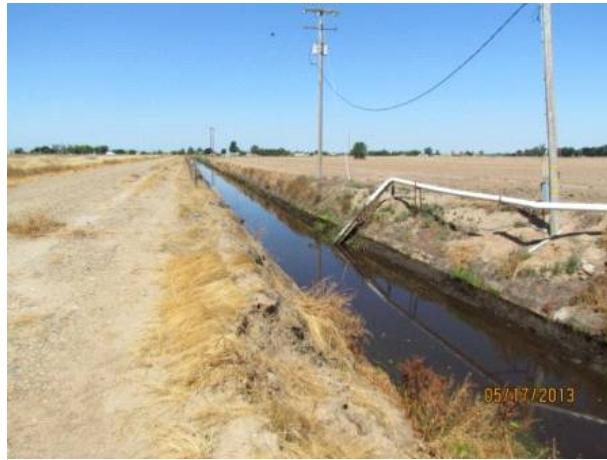
Levee Mile Report Line	5
Start Levee Mile	0.71
End Levee Mile	0.97
Location	Land Side
Category	Earthen Levee
Item	Encroachments
Updated picture of the agricultural ditch on the landside of the levee looking downstream.	pkazi_f_20131001_210.JPG

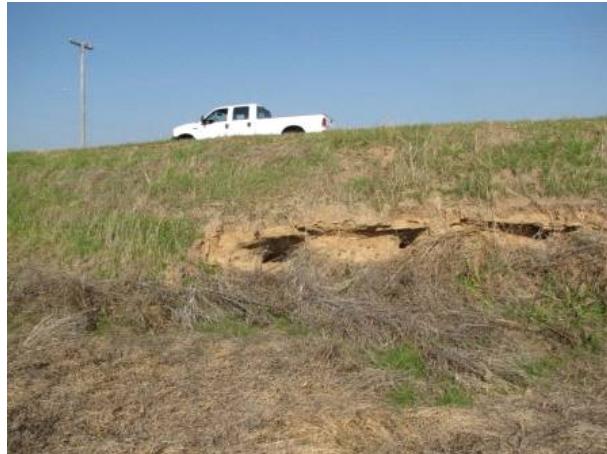
Levee Mile Report Line	6
Start Levee Mile	0.87
End Levee Mile	0.87
Location	Water Side
Category	Earthen Levee
Item	Animal Control
View of rodent holes in the waterward berm from the channel.	
pkazi_f_20131001_207.jpg

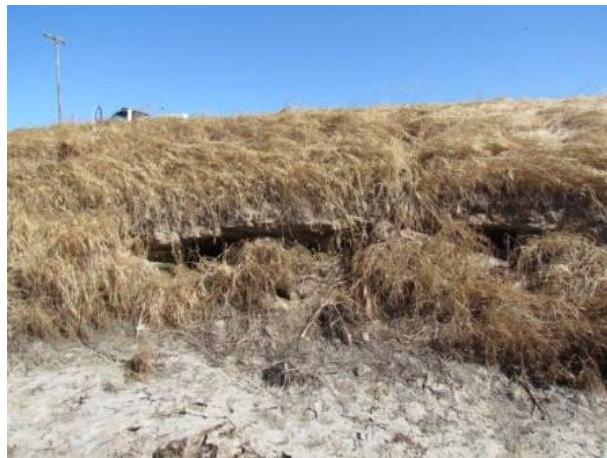
Levee Mile Report Line	6
Start Levee Mile	0.87
End Levee Mile	0.87
Location	Water Side
Category	Earthen Levee
Item	Animal Control
Erosion above the pilot channel was located but it didn't look like rodent holes. The picture was taken from the toe at the waterside of the levee looking towards the crown.	
pkazi_f_20131001_208.jpg

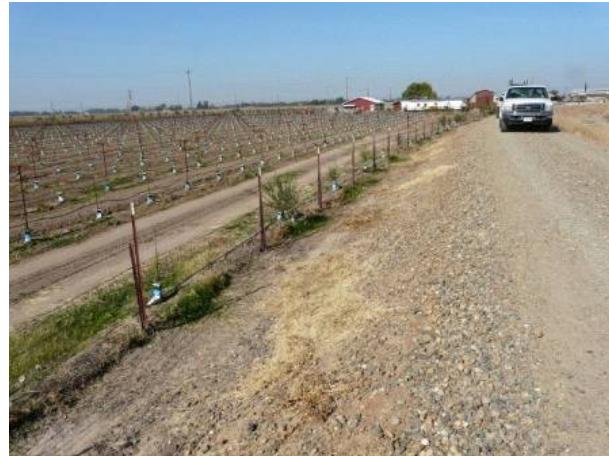
Levee Mile Report Line	1
Start Levee Mile	0.17
End Levee Mile	0.49
Location	Land Side
Category	Earthen Levee
Item	Encroachments
Fence located from LM 0.17 to LM 0.49 and crops located from LM 0.17 to LM 0.41 within 10' from landside toe of levee.	pkazi_f_20131001_213.JPG

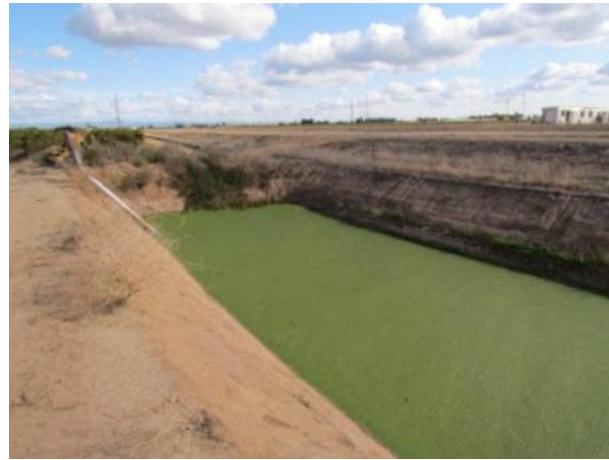
Levee Mile Report Line	3
Start Levee Mile	1.07
End Levee Mile	1.14
Location	Land Side
Category	Earthen Levee
Item	Encroachments
View of the ditch on the landside of the levee looking upstream. The picture was taken during fall 2011 inspection.	pkazi_f_20131001_220.jpg

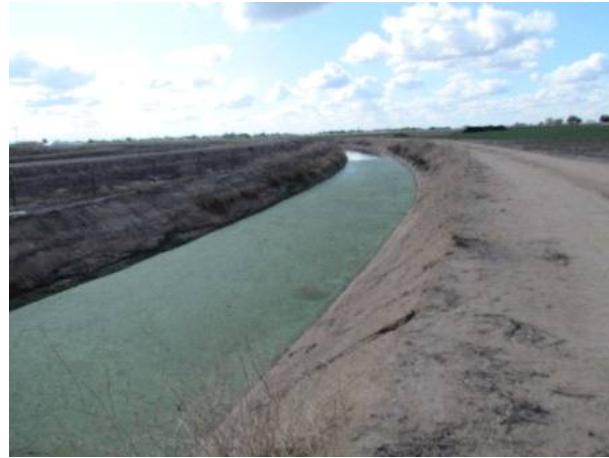
Levee Mile Report Line	3
Start Levee Mile	1.07
End Levee Mile	1.14
Location	Land Side
Category	Earthen Levee
Item	Encroachments
Updated picture of the ditch on the landside of the levee. The picture was taken during fall 2013 inspection looking upstream.	
pkazi_f_20131111_042.JPG

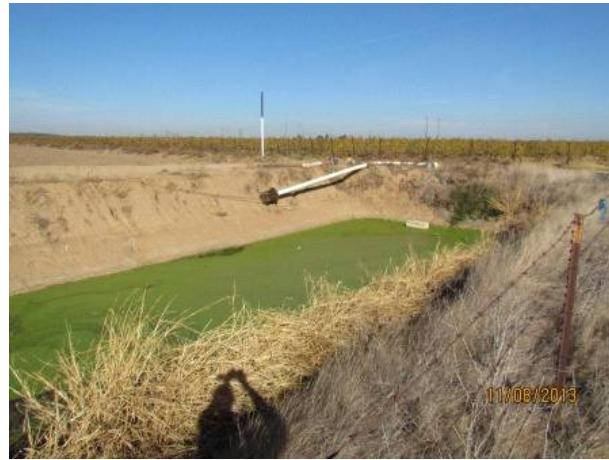
Levee Mile Report Line	3
Start Levee Mile	1.07
End Levee Mile	1.14
Location	Land Side
Category	Earthen Levee
Item	Encroachments
This notice of violation was given to the property owner who constructed the ditch.	
pkazi_f_20131001_222.jpg

State of California	DEPARTMENT OF WATER RESOURCES Division of Flood Management/Flood Project Inspection Section	The Resources Agency
<b>NOTICE OF VIOLATION</b>		
DATE: 11/4/2011	LOCATION: NORTH PADDY CREEK	LANDOWNER/CONTRACTOR: Frank Shaws Shaws Dairy
A Department of Water Resources' Inspector has found you in violation of Title 23 of the California Code of Regulations which protects floodways and flood control structures.		
TYPE OF VIOLATION

4. <input type="checkbox"/> IMPROPER MAINTENANCE 5. <input type="checkbox"/> OTHER _____		
REQUESTED CORRECTION: Repair the ditch at the landside toe of the levee. The ditch is approximately 10 feet in width from the toe of the levee likely to cause significant levee stability issue.		
Corrective action must be taken no later than _____. If you have questions about this notice, please contact the inspector listed below. If corrective action is not taken, the Department may request that enforcement action be taken against you.		
Received By: <u>Frank Shaws</u>

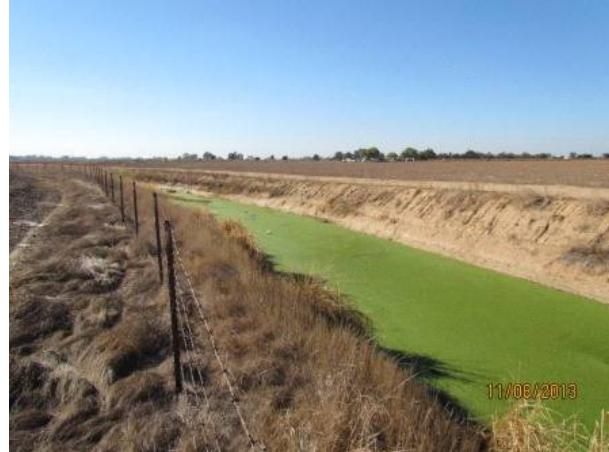
Levee Mile Report Line	3
Start Levee Mile	1.07
End Levee Mile	1.14
Location	Land Side
Category	Earthen Levee
Item	Encroachments
Updated picture of the ditch on the landside of the levee during fall 2013 inspection looking downstream.	
pkazi_f_20131111_043.JPG

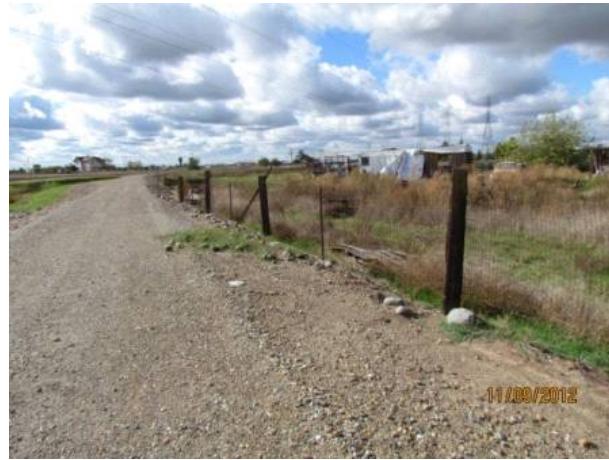
Levee Mile Report Line	5
Start Levee Mile	2.25
End Levee Mile	2.42
Location	Land Side
Category	Earthen Levee
Item	Encroachments
A fence was found on the landside toe of the levee looking downstream.	
pkazi_f_20131001_216.jpg

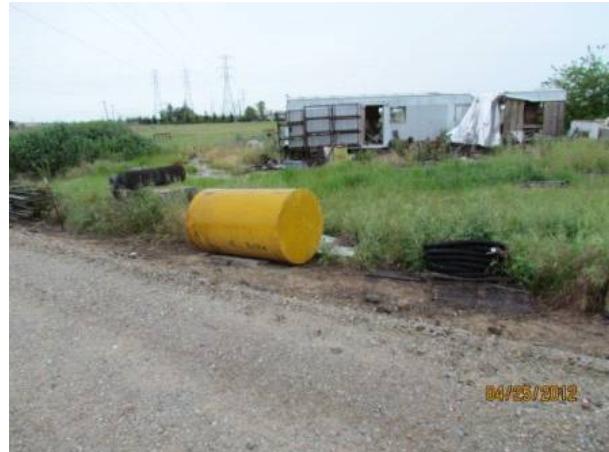
Levee Mile Report Line	6
Start Levee Mile	2.40
End Levee Mile	2.40
Location	Land Side
Category	Earthen Levee
Item	Encroachments
A tank and debris was found on the landside of the levee looking downstream.	
pkazi_f_20131001_218.jpg

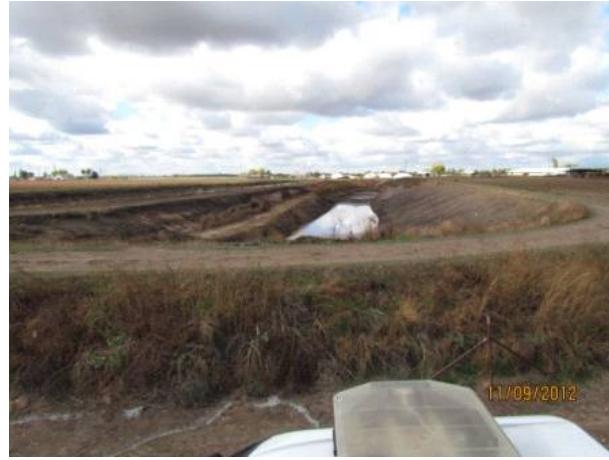
Levee Mile Report Line	8
Start Levee Mile	2.97
End Levee Mile	2.97
Location	Land Side
Category	Earthen Levee
Item	Encroachments
A detention pond was found next the landside toe of the levee. The pond had approximately depth of 15 feet. The picture was taken from the crown looking towards the toe of the levee.	
pkazi_f_20131001_219.jpg
